# Removing Bees from a house wall

## D. Hoban - Victoria

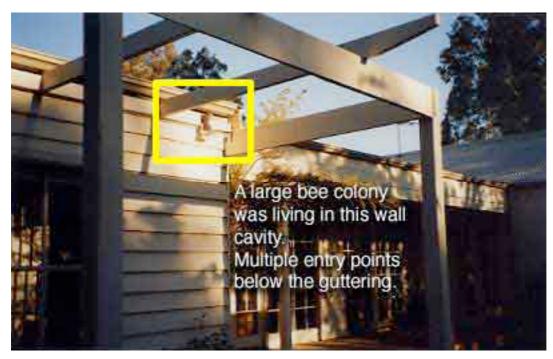
Figure 1. The colony is located

I visited this house several times to establish where the bees were located. I use a stethoscope to determine the extent to which the bees fill a wall cavity.

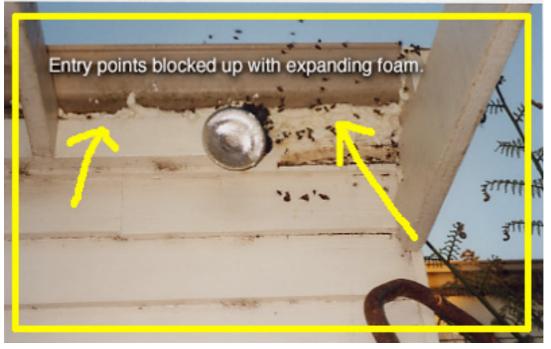
## Step 2. Blocking up the entry points

Expanding foam was used here because it was easy at the time. I usually use insulating foil and staples.

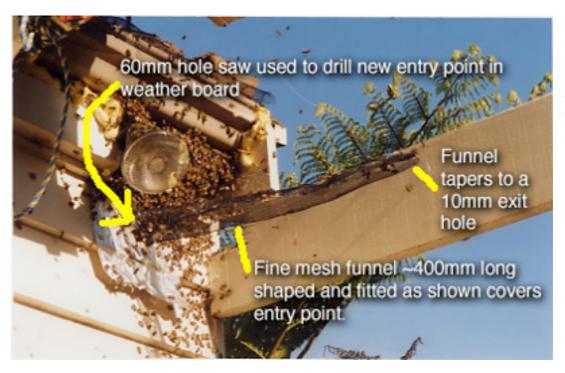
### Step 3. The trap is set...

This is a one way exit for the bees. They find their way out easy enough but can't get back in. You may need to make the exit hole bigger – you do want the bees to get out.

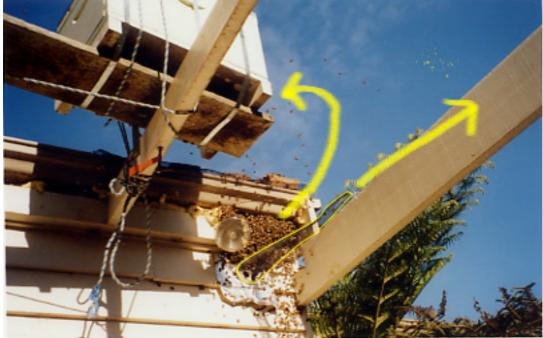
## Step 4. The trap is working

Bees leave the wall cavity via the funnel. They mass near their old entry point. Gradually they give up on getting back to their queen and join the colony in the box placed ever so conveniently

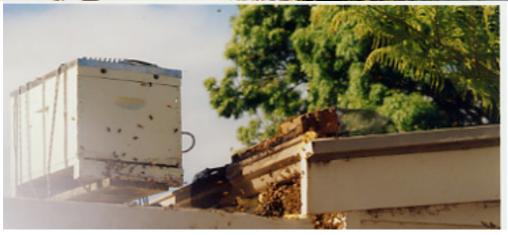
Figure 3. Hive body in position to attract bees trapped outside of wall.

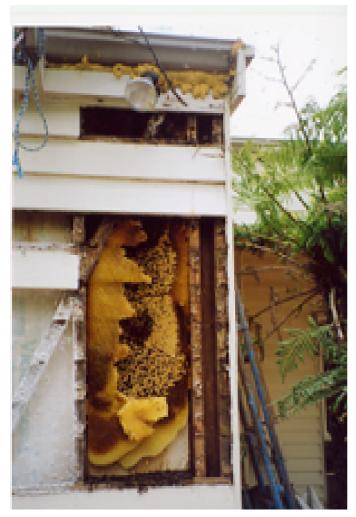
#### Step 5. Remove the comb, clean up and replace the boards

(You may notice the white powder in the adjoining cavity in the photo on the left, this was the work of the previous exterminator who had injected the insecticide into the wrong wall cavity.)

It will take at least 4 weeks for the bees to make a new home outside of the wall cavity. Make sure that there are no more bees exiting from the funnel.

When you open the cavity to remove the comb there may be a few remnant bees, newly hatched bees and a queen. It is important that if you see the queen you catch/and or kill her to ensure that bees do not settle somewhere else on the house.

Once all the comb is removed it is a good idea to scape any residual comb and scrub it down with a mild sugar soap solution remove any of the bee odour which may attract other bees. (Chemical alternative is Bleach)

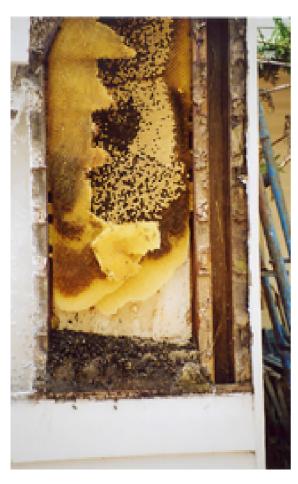
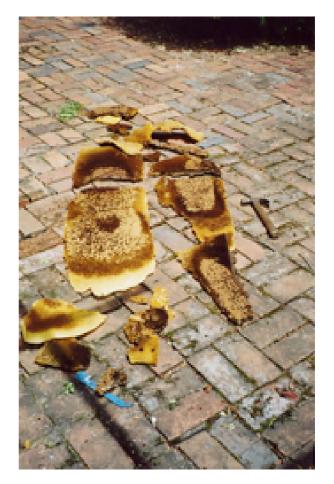
(left and below the comb removed)
